**Flood Control Project Maintenance
Levee Inspections**

Fall 2016 Levee Maintenance Deficiency Summary Report

Reclamation District No. 0001 Union Island

| Waterway | | | Bank | Unit Miles |
|--|---|---|---|---|
| Unit No. 01 Old River | | | Right | 1.14 |

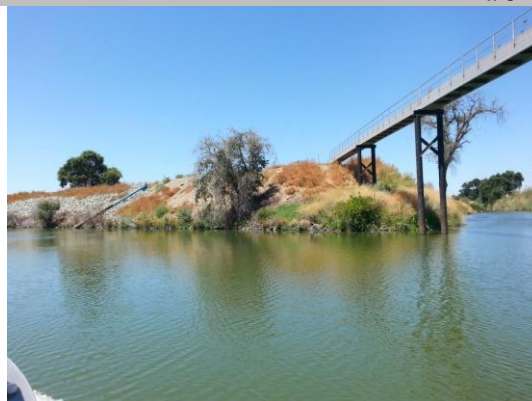
Photo 1 of 3 : SJR2016_RD0001U01RM31.4_1.jpg

| 08/07/2012: The erosion is at the confluence of Old River and one of its tributary. [2016 Site ID:RD0001U01RM31.4] | | | | | |

Upstream view of the erosion.

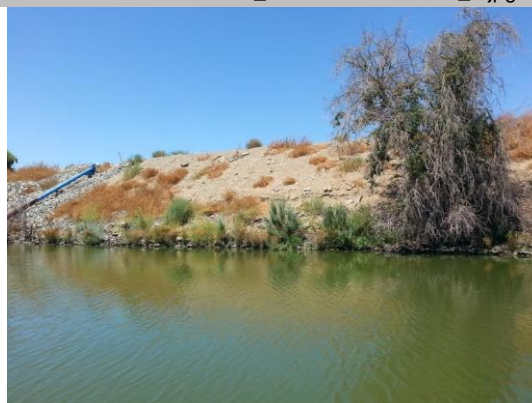
Photo 2 of 3 : SJR2016_RD0001U01RM31.4_2.jpg

Close view of the erosion.

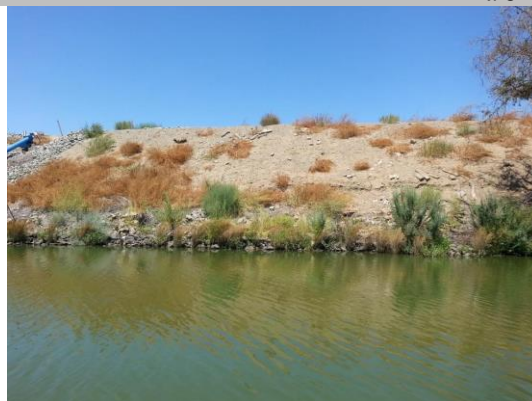
Photo 3 of 3 : SJR2016_RD0001U01RM31.4_4.jpg

Front view of the site. Note the large tree on site.

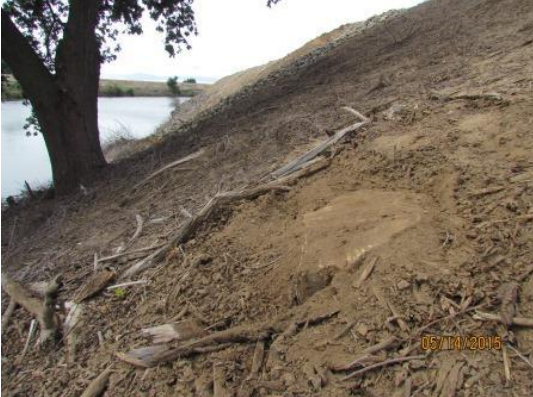
Photo 1 of 1 : FA_2001_RD0001_23_12_20160914_00009.jpg

View of the tree stump on the waterside levee slope.

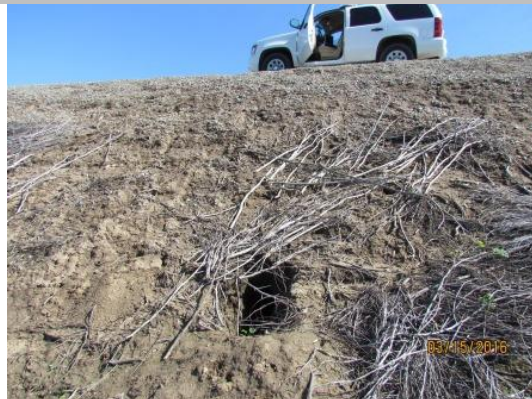
Photo 1 of 1 : FA_2016_RD0001_23_10_20160914_00007.jpg

View of the large rodent hole on the landside levee slope.

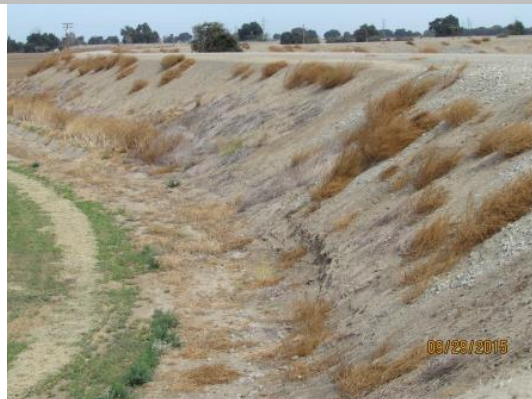
Photo 1 of 1 : FA_2016_RD0001_23_5_20160914_00005.jpg

View of the vertical cut at the landside levee toe.

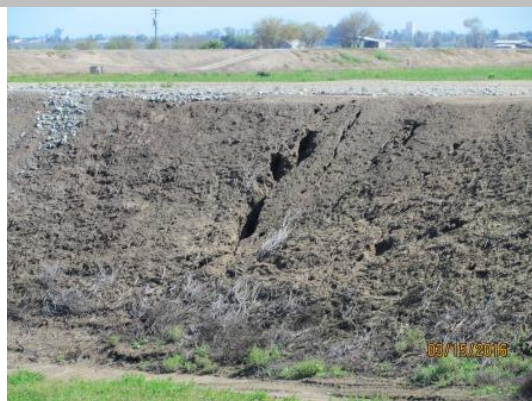
Photo 1 of 1 : FA_2016_RD0001_23_7_20160914_00006.jpg

View of the erosion on the landside levee slope.

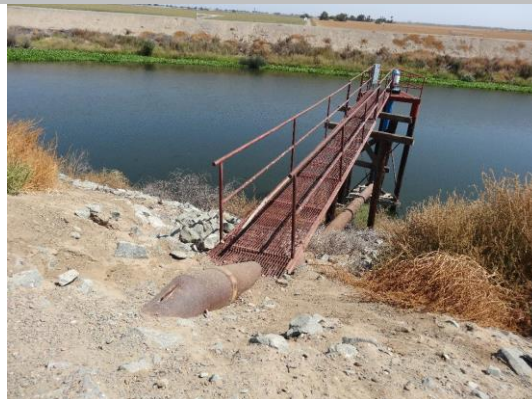
Photo 1 of 2 : UCIP_FA_2016_41600_36004.jpg

| UCIP Comments: - 2" electric conduit on WS- pipe exposed on both sides.- power pole on LS. - erosion on WS hinge near walkway. | | | | | |

WS view: exposed pipe, walkway, and pump on pile structure. Soil erosion on levee hinge near walkway.

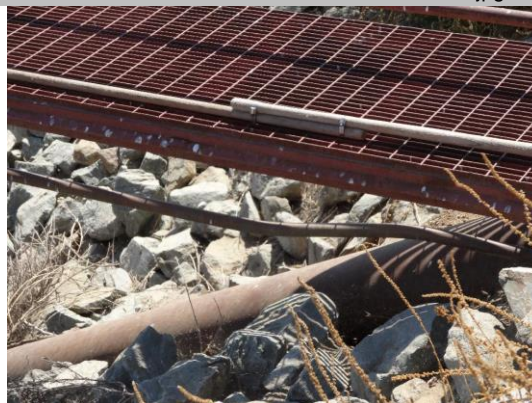
Photo 2 of 2 : UCIP_FA_2016_41600_36003.jpg

WS view: exposed pipe, walkway, and electric conduit under walkway. Rock revetment on lower levee slope.

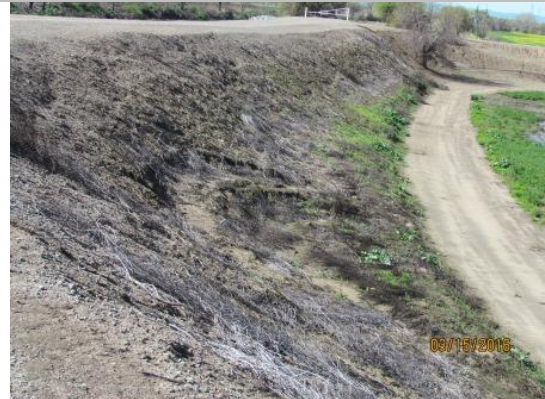
Photo 1 of 1 : FA_2016_RD0001_23_3_20160914_00003.jpg

View of the landside slope damaged by farm equipment.

| S3 : Repair the levee slope damaged by vehicle traffic and prevent access where possible. | | | | | |
| Repair slope damaged by vehicle by placing and compacting acceptable levee material. | | | | | |
